WICHITA FALLS CULTURAL RESOURCES SURVEY
 WICHITA COUNTY HERITAGE SOCIETY
 SURVEY FORM

NAME OF SITE: _____ ADDRESS: 2314 10th

LEGAL DESCRIPTION: Subdivision Floral Heights Block _____ Lot _____

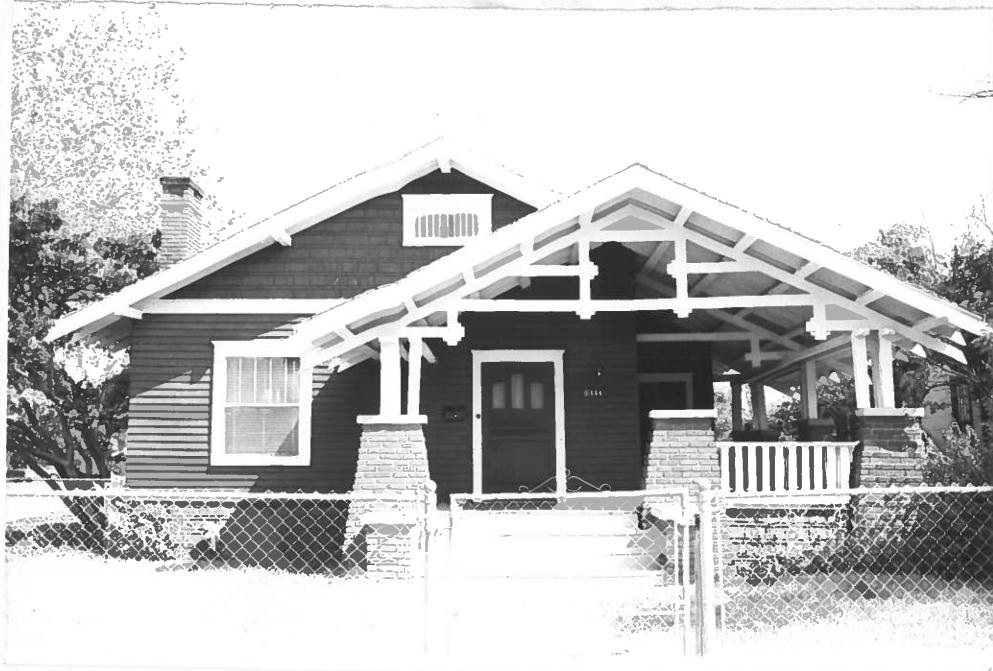
PHOTO DATA: Roll 8 Frame 11

PHYSICAL DESCRIPTION: One-story wood frame residence; irregular shape with double gable roof; end chimney; open framing on porch gable repeats house roofline; framing repeated on side of porch; shingles cover front gable and skirt around foundation; 2 bay with single front door.

CONDITION OF EXTERIOR: good

ALTERATIONS/ADDITIONS: none visible

ARCHITECTURAL STYLE/TYPE AND SIGNIFICANCE: Bungalow - open gable framing of porch particularly interesting on this small bungalow.
