WICHITA FALLS CULTURAL RESOURCES SURVEY
 WICHITA COUNTY HERITAGE SOCIETY
 SURVEY FORM

NAME OF SITE: Bristol-Teer ADDRESS: 106 Pembroke
 LEGAL DESCRIPTION: Subdivision #28-Part #6 Morningside Park Block Lot
 PRESENT OWNER: J. E. Teer
 and MAILING ADDRESS: 106 Pembroke
 CATEGORY: District ☒ Building Structure Site Object
 ORIGINAL USE: residence PRESENT USE residence ~~ZONING~~
 PHYSICAL DESCRIPTION: One-story rectangular plan with gable roof. Paired fenestration-
8 over 1 sash. Arched entrance with gable overhang. One exterior front chimney. Side
porch with brick pillars and half-timbering in gable end. Garage apartment.
 MATERIALS: wall brick roof composition shingles
 CONDITION OF EXTERIOR: excellent
 ALTERATIONS/ADDITIONS: None discernible.
 ARCHITECTURAL STYLE/TYPE AND SIGNIFICANCE: Bungalow Influence
 SIGNIFICANT PERSONS AND EVENTS ASSOCIATED WITH SITE: Built 1925.
 RELATIONSHIP TO SURROUNDINGS: Part of scene.
 CURRENT TAX ASSESSMENTS:

NAME: Bristol-Teer
ADDRESS: 106 Pembroke
COUNTY: Wichita
CITY: Wichita Falls
UTM: _____
DATE: 1925 PERIOD: 1900-
STYLE: Bungalow Influence
THEME: _____

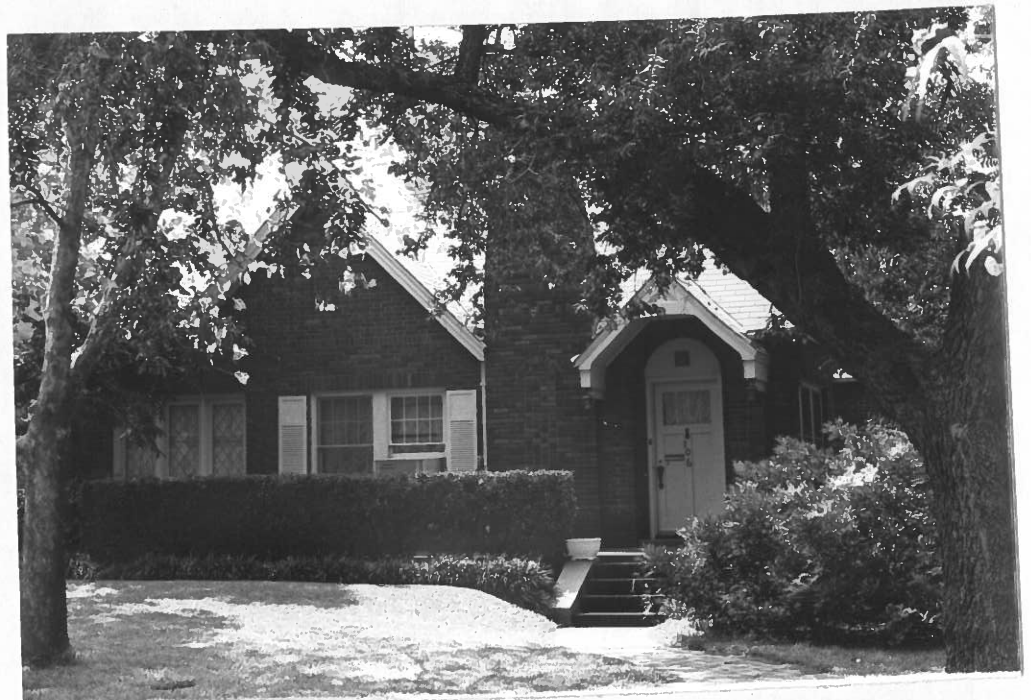
PHOTO DATA: Roll 1 Frame 17RECORDED BY: Ellen Beasley; Susan H. Campbell Date March, 1982

DESCRIPTION: One-story rectangular plan with gable roof. Paired fenestration - 8 over 1 sash. Arched entrance with gable overhang. One exterior front chimney. Side porch with brick pillars and half-timbering in gable end. Garage apartment.

BUILDING MATERIAL: wall: Brick roof: Composition shingles
PHYSICAL CONDITION: Excellent SITE: original ☒ or moved _____ date _____
ALTERATIONS: _____
SIGNIFICANCE: _____
