WICHITA FALLS CULTURAL RESOURCES SURVEY  
WICHITA COUNTY HERITAGE SOCIETY  
SURVEY FORM

NAME OF SITE: MHMR ADDRESS: 1800 Rose

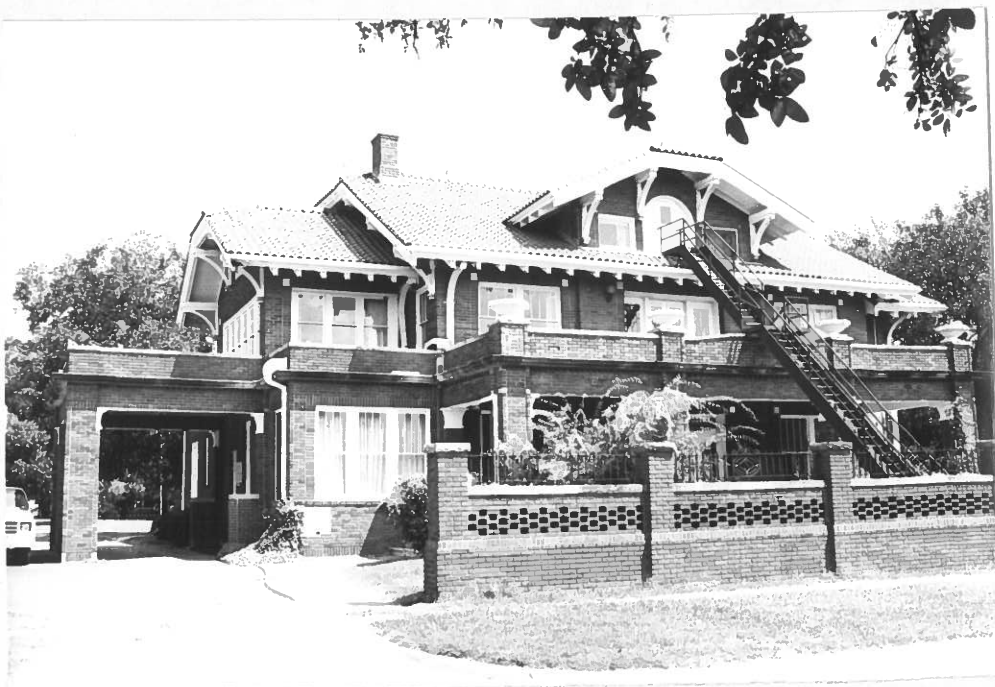
PHOTO DATA: Roll 8 Frame 32

PHYSICAL DESCRIPTION: 2 1/2-story brick residence; rectangular shape with clipped gable roof; form repeated on small side extensions; center dormer with clipped gable roof and center arched window; wide eaves with knee braces; attached porch with second floor open balcony; 3-bay on main section; port-cochere; brick wall encloses large yard.

CONDITION OF EXTERIOR: good

ALTERATIONS/ADDITIONS: minor [but have great impact] - fire escape from 3rd story window on front.

OTHER COMMENTS/OBSERVATIONS: If not properly cared for, property could have very negative impact on area. Research needs clarification. Should not be considered as landmark until fire escape is resolved in compatible manner.
